Emergency Communications System Series 4200

Operation Instructions

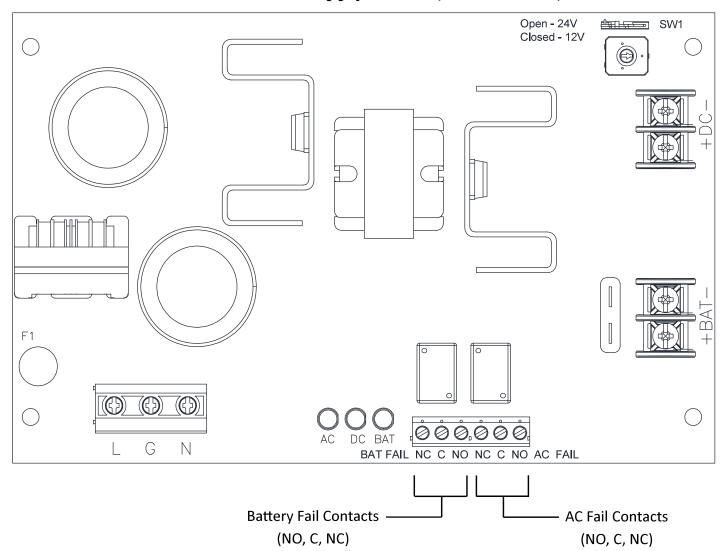
B-5243A Power Supply Board (shown below):

Cornell Model B-5243A Power Supplies each provide (2) Form-C (SPDT) Trouble Relays on the Power Supply for monitoring primary 120VAC input power (AC FAIL) and

LABELING = One side labeled as "BAT FAIL" / The other side labeled as "AC FAIL"

OPERATION = BAT FAIL = Actuates upon failure or disconnection of the batteries or charging circuits. Resets

AC FAIL = Actuates upon failure of Primary AC Power to the Power Supply. Resets upon

re-application of AC Power.
